SCENARIOS FOR THE FUNCTIONING OF THE KAKHOVKA RESERVOIR TERRITORY

VITALII PICHURA^{1*}, LARYSA POTRAVKA¹, NATALIYA STOIKO²
AND HALYNA DUDYCH²

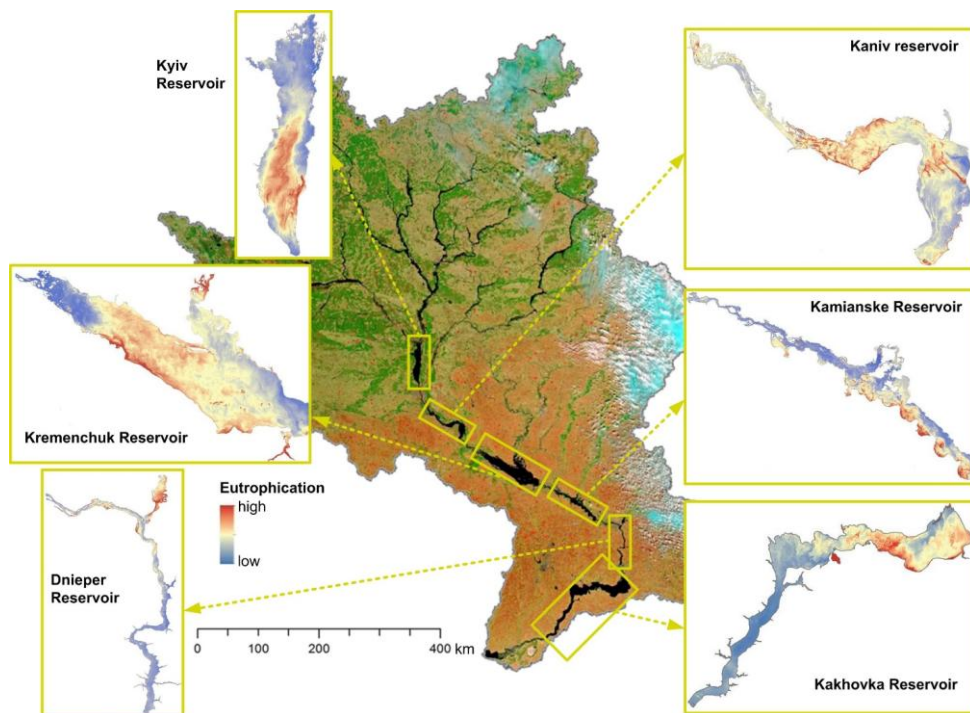
Fig. 2: The cascade of the Dnipro reservoirs and eutrophication of surface waters

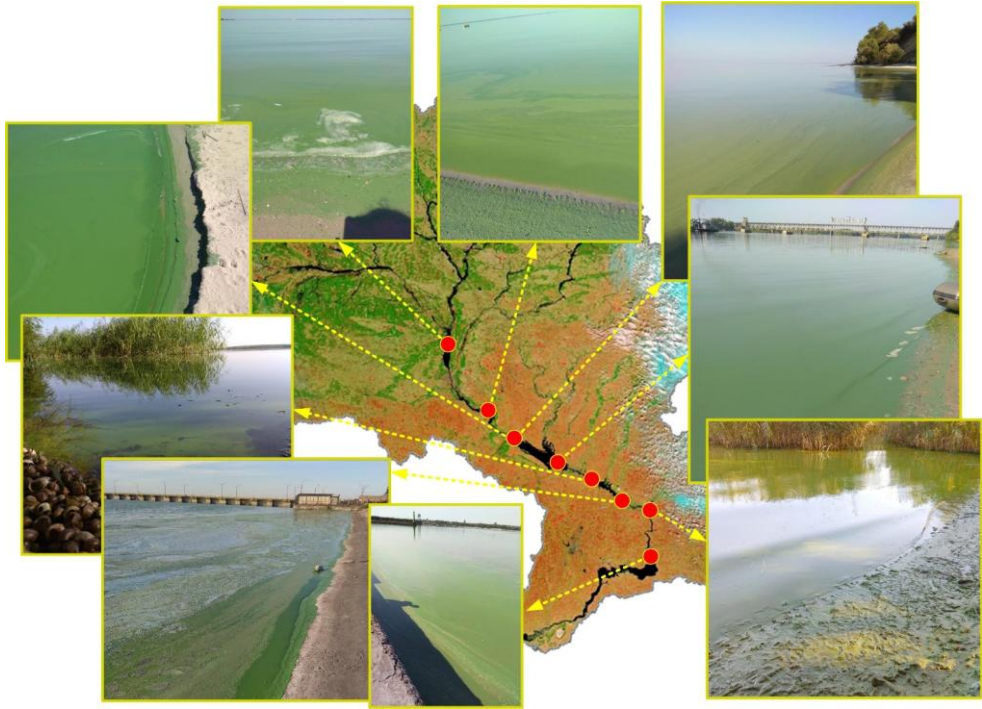
Fig. 3: Cyanobacteria bloom in the Dnipro water in August 2019

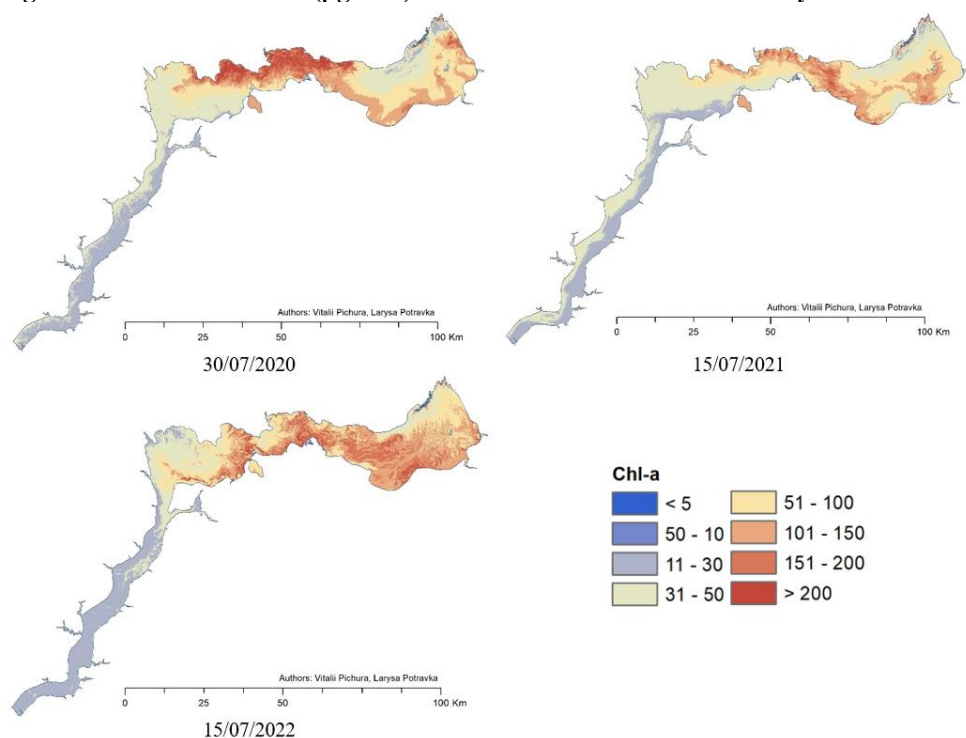
Fig. 4: Chl-a concentration ($\mu\text{g}/\text{dm}^3$) in the Kakhovka Reservoir in July 2020–2022

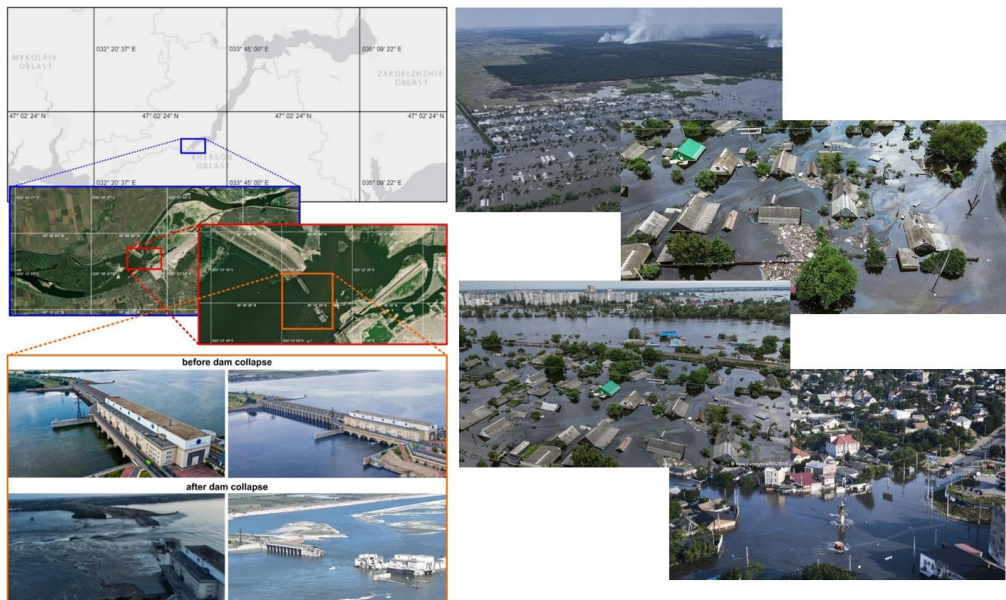
Fig. 5: The destruction of the dam of the Kakhovka HPS

SCENARIO 2 – the creation of a natural plant ecosystem. The destruction of the dam of the Kakhovka HPS (Fig. 5) caused a natural-climatic transformation of the drained Reservoir (Fig. 6) and a catastrophic moisture deficit in the southern regions of Ukraine.

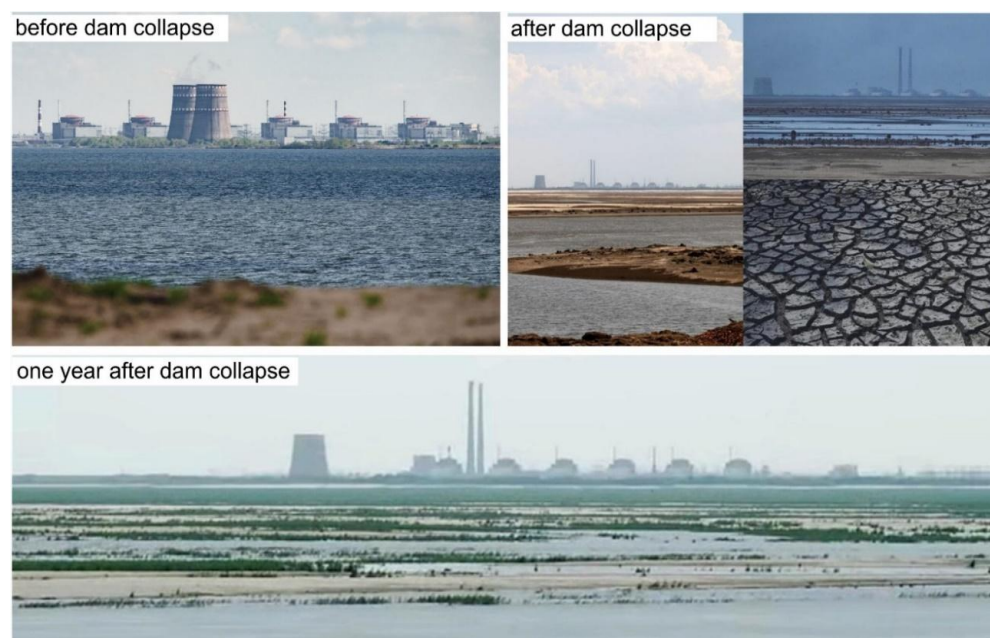
Fig. 6: The change in the state of the Kakhovka Reservoir in 2023–2024 (the view from Nikopol to Zaporizhzhia NPP)

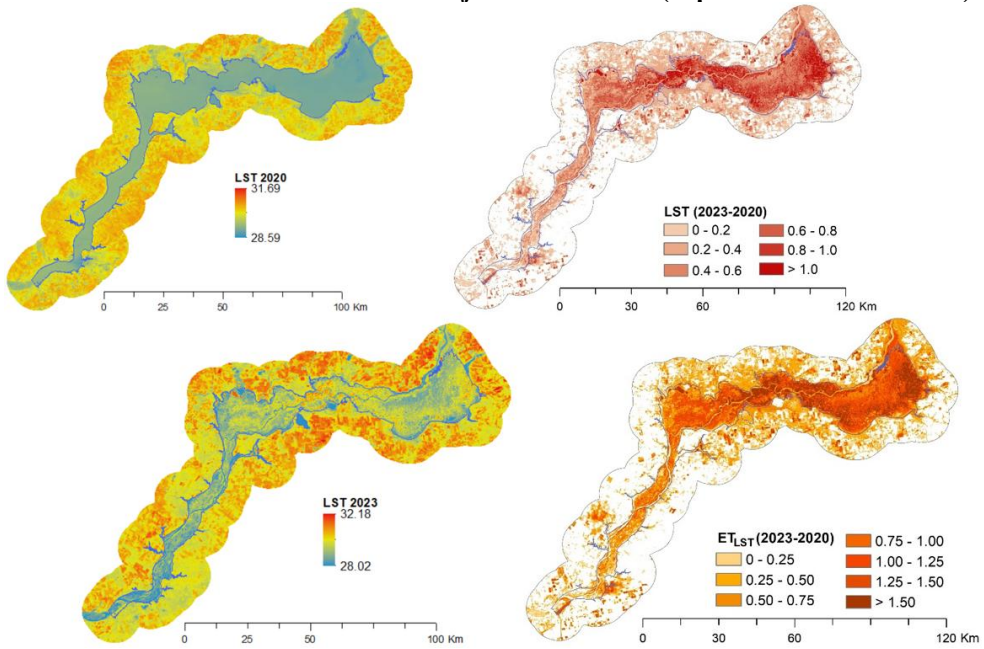
Fig. 7: Patterns of changes in LST (°C) and ET_{LST} (mm/day) in the territory of the drained Kakhovka Reservoir and the adjacent territories (September 2020 and 2023)

In the daytime, the breeze circulation occurred as a result of heating and convective flows rising above the land, which were replaced by cooled air flowing from the Reservoir to the lower surface layer. At night, when the landscape surface cooled, reverse circulation occurred. The existence of the Kakhovka Reservoir determined the formation of a horizontal-vertical fast and powerful breeze, which formed a favorable micro-climate on the steppe plains stretching for tens of kilometers from the Reservoir. Therefore, the reservoir drainage disrupted the micro-climatic conditions, causing an increase in the heating temperature on the adjacent landscape (Land Surface Temperature – LST) by 1.0°C and more (Fig. 7). This resulted in an increase in the area with temperature stress by 58.2 %, worsening the problem of water scarcity, acceleration of seasonal evaporation (evapotranspiration – ET_{LST}) up to 50 % and more in 2023.

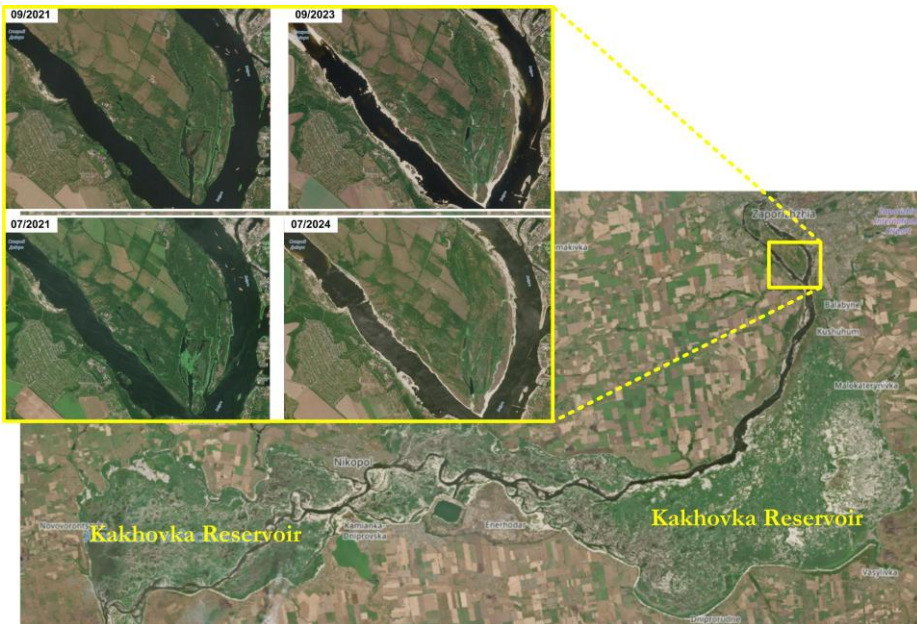
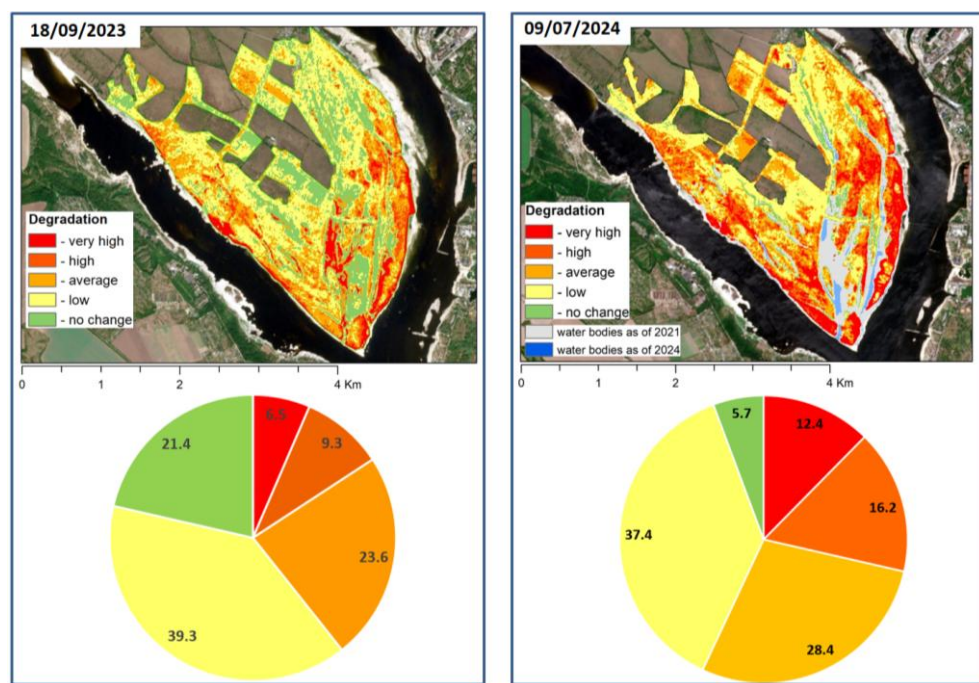
Fig. 8: Floodplain systems of the Khortytsia National Reserve: a – the location and years of comparison of the state of floodplain systems; b – degradation of floodplain systems

Degradation of the floodplain systems of the Khortytsia National Reserve. A reduction in the water level by 4.0 meters and more in the area of the lower course below the dam of the Dnipro HPS in September 2023 caused degradation of 78.6 % (550 ha) of unique floodplain systems of the Khortytsia National Reserve. Abnormally favorable winter-spring climatic conditions in 2024 led to an increase in the water level in the lower Dnipro, ensuring a high level of moisture in this period. This contributed to a partial seasonal restoration of 35.1 % of the floodplain systems of Khortytsia Island. However, a reduction in the discharge from the Dnipro HPS and water shortages against the backdrop of high summer temperatures led to catastrophic degradation of floodplain plants in 94.3 % of the area (660 ha) (Fig. 8).

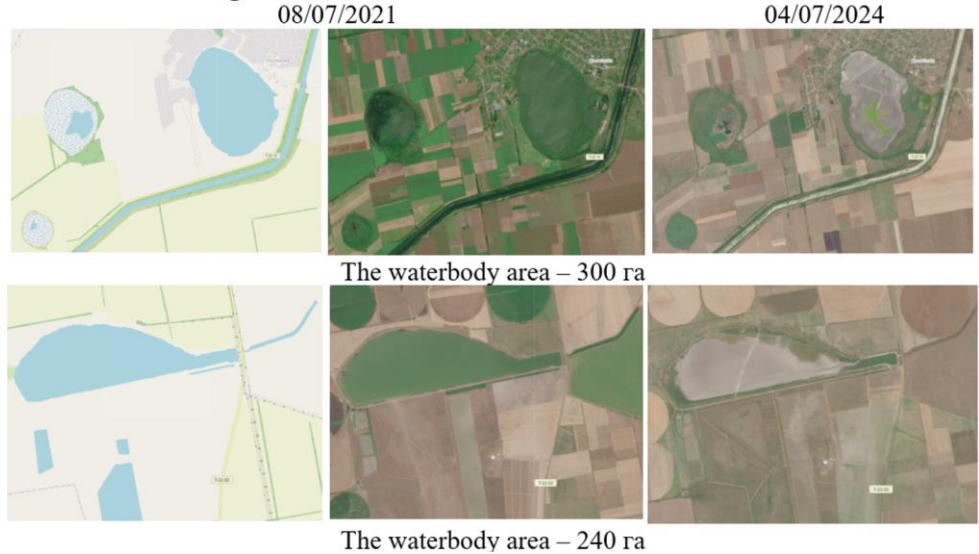
Fig. 9: The drainage of waterbodies in the temporarily occupied territories on the Left Bank of Kherson region in 2024

The destruction of the primary source of irrigation for the southern regions caused extreme water shortages, the drainage of water bodies (Fig. 9), evaporation and a reduction in the water table, the transfer of salts to the upper soil layer, and a rise in their concentration, an increase in the area with secondary salinization and salinity (Fig. 10).

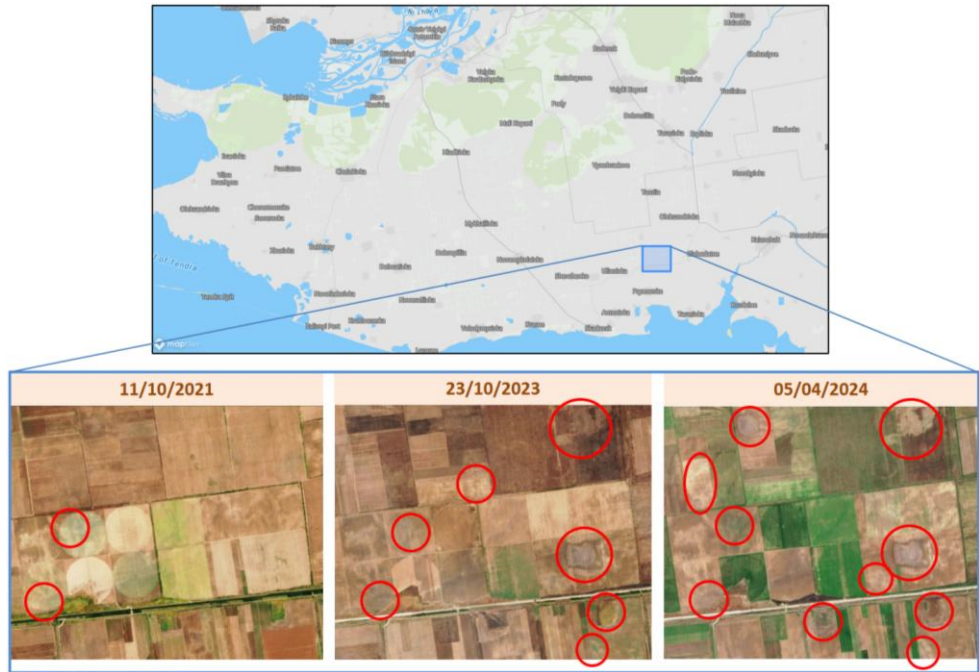
Fig. 10: An increase in the number of saline lands due to a lack of agricultural practices and irrigation in the temporarily occupied territory on the Left Bank of Kherson region (the research territory is 2.1 thousand hectares, the areas of secondary salinization are circled in red)

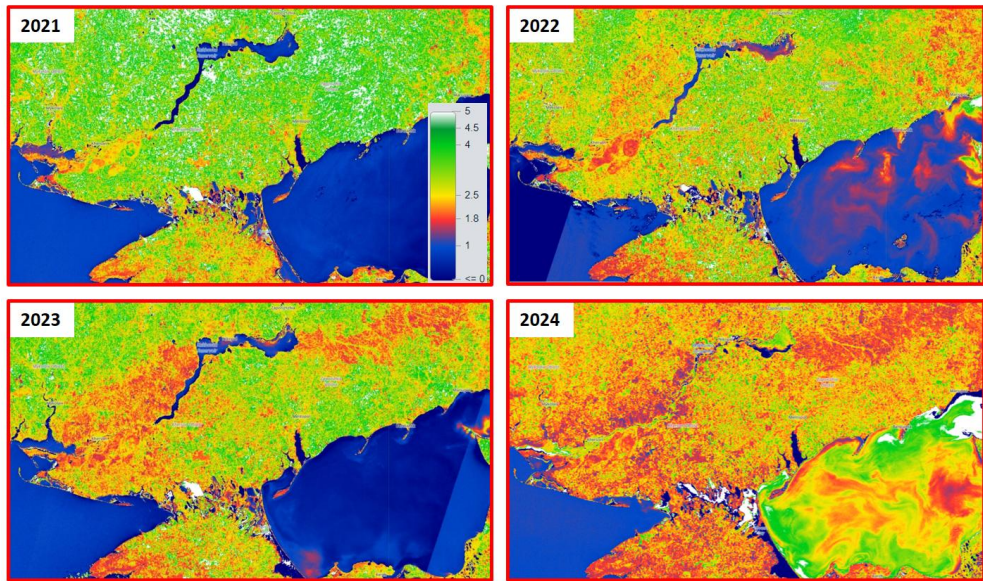
Fig. 11: A change in the values of the Terrestrial Chlorophyll Index in the South of Ukraine in May 2021–2024

Low OTCI values indicate the presence of water, sand, or snow. The elevated value highlighted in white testifies to the lack of chlorophyll (vegetation) indicating bare soil and stone. Chlorophyll values in the range from red (low chlorophyll values) to dark green (high chlorophyll values) indicate the presence and the corresponding state of vegetation. Within water bodies, white color is characteristic of water areas with high surface water pollution by suspended and organic substances.

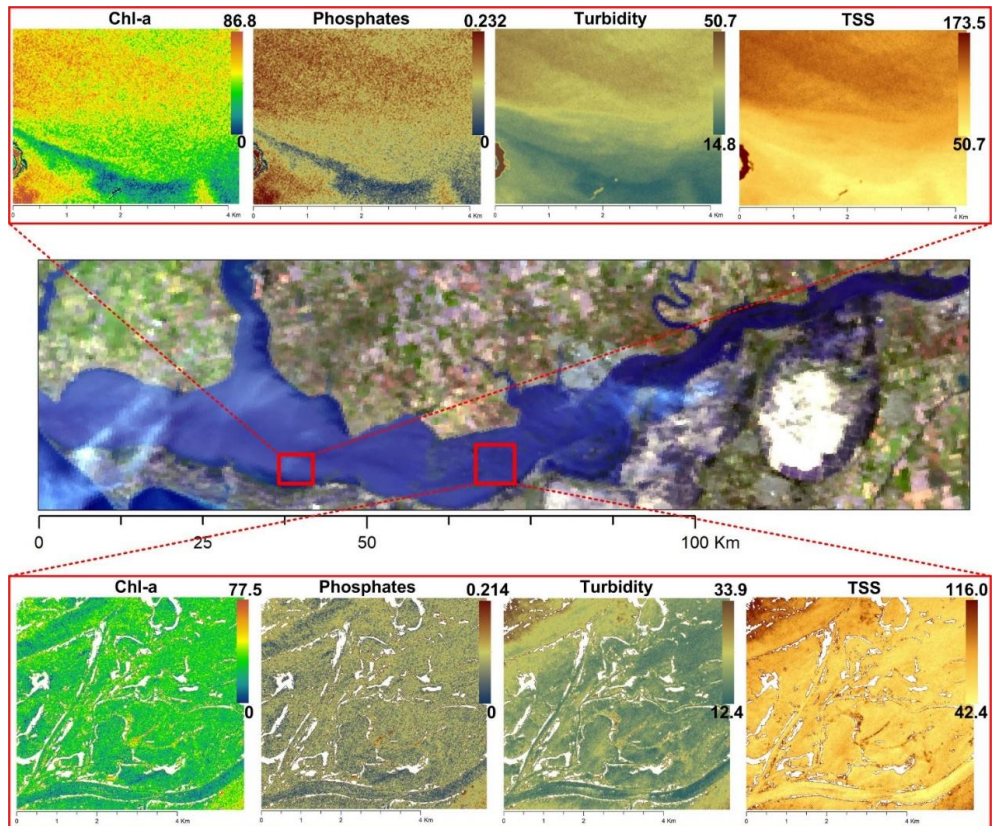
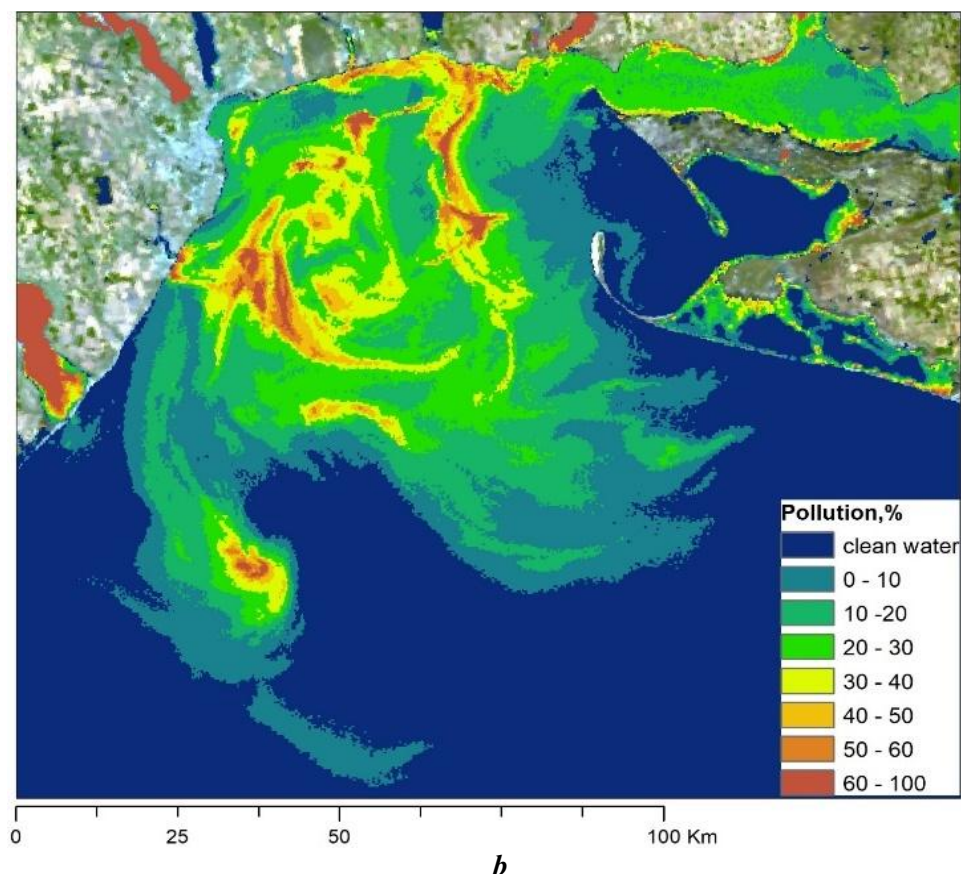
Fig. 12: Water pollution in the Dnipro-Buh estuary system (a) and the Black Sea (b) in the period of 08–24/06/2023

Water quality degradation in the Dnipro-Buh estuary system and the Black Sea. The research was conducted using hydro-biological, biological, and physical-chemical indicators that characterize the water quality and the functioning of the water area. It was established that the destructive consequences of the Kakhovka dam breach manifested in the reservoir drainage, the release of pollutants with a concentration of 1.1–51.8 MPC, and the pollution of water resources in the area of 6800 km² of the estuary system, and the Black sea (Fig. 12).

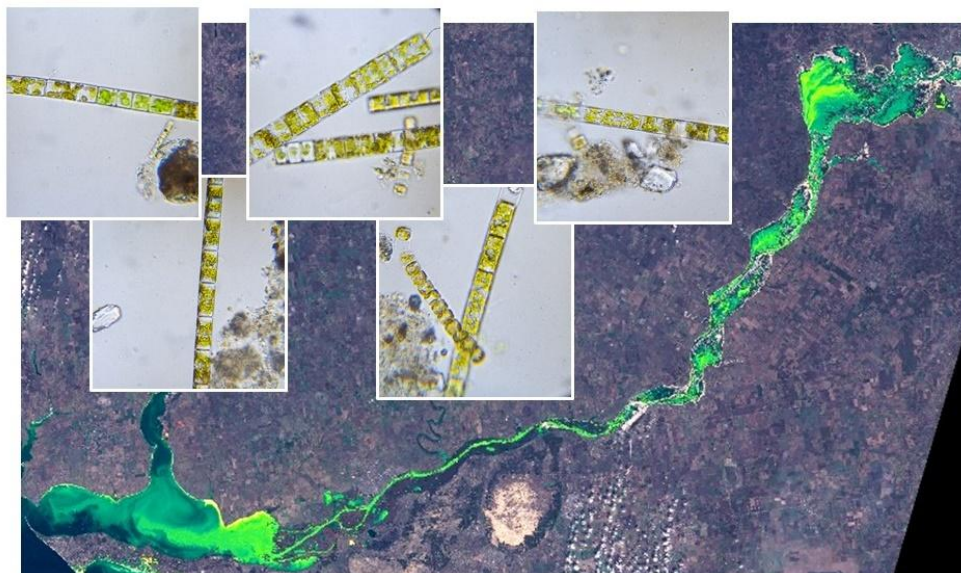
Fig. 13: Active reproduction of *Melosira varians* in the Dnipro-Buh estuary system as of March 2024

In March–April 2024, there was an abnormal increase in phytoplankton concentration in the waters of the Dniro-Buh estuary systems. The phytoplankton biomass ranged from 4.17 to 5.23 mg/dm³ in deep flowing waters of the water area and from 8.12 to 15.43 mg/dm³ in the shallow shoreline areas. The water quality corresponded to eutrophic and polytrophic conditions regarding biological productivity. An increase in phytoplankton concentration was caused by the movement of microscopic diatomic algae *Melosira varians* (filamentous algae) with the water masses from the territory of the Kakhovka Reservoir. This led to the transfer of colonial diatomic *Melosira varians* by the river flow and increased their share in the Dniro-Buh estuary system (Fig. 13) from 15.0 to 86.7 %. Being naturally cryophilic (cold-tolerant), these algae formed large volumes of biomass. A slight increase in water temperature to 5°C is a favorable condition for intensive reproduction of *Melosira varians*, whereas the growing season of other algae has not started yet.

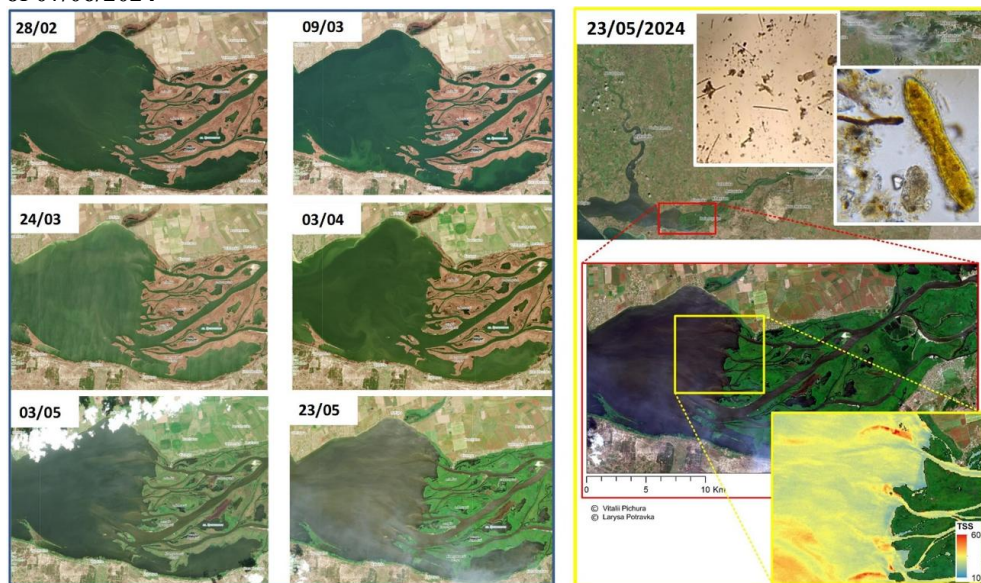
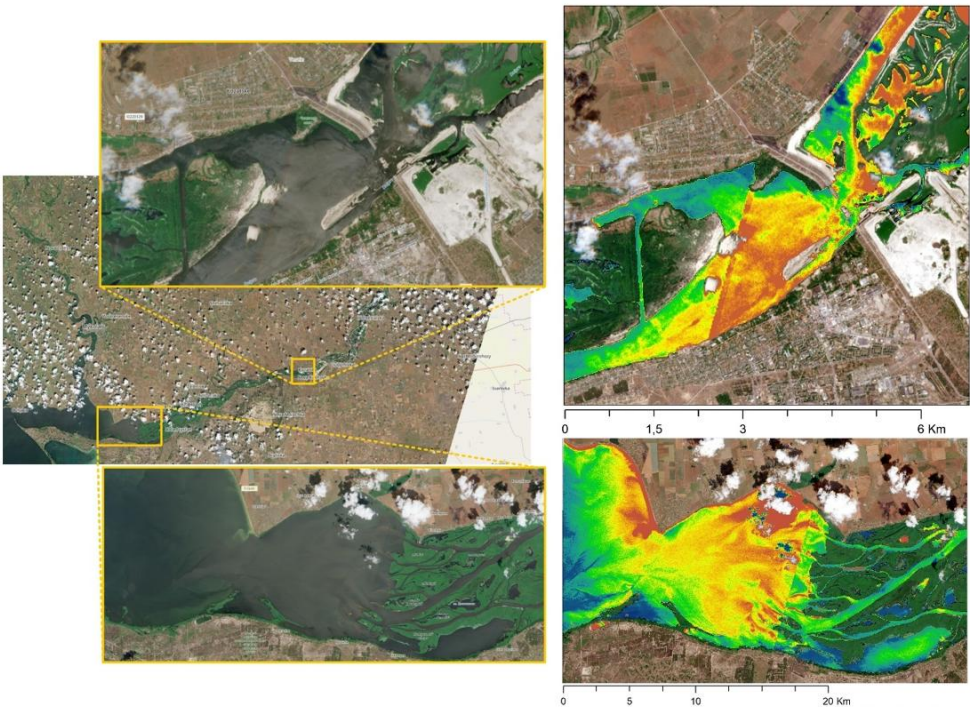
Fig. 14: Pollution of the Dnipro-Buh estuary system: *a* – in February–May 2024; *b* – as of 07/06/2024

The water quality corresponds to III-V levels of pollution – “moderately polluted” (green color), “dirty” (yellow color), “very dirty” (brown color)

In the water samples from the Dnipro River taken in the spring of 2024, there was a high concentration of suspended and organic substances, a high density of plant residues, and protozoa remains. Pollutants are carried by the river flow to the Dnipro-Buh estuary and the Black Sea (Fig. 14, 15).

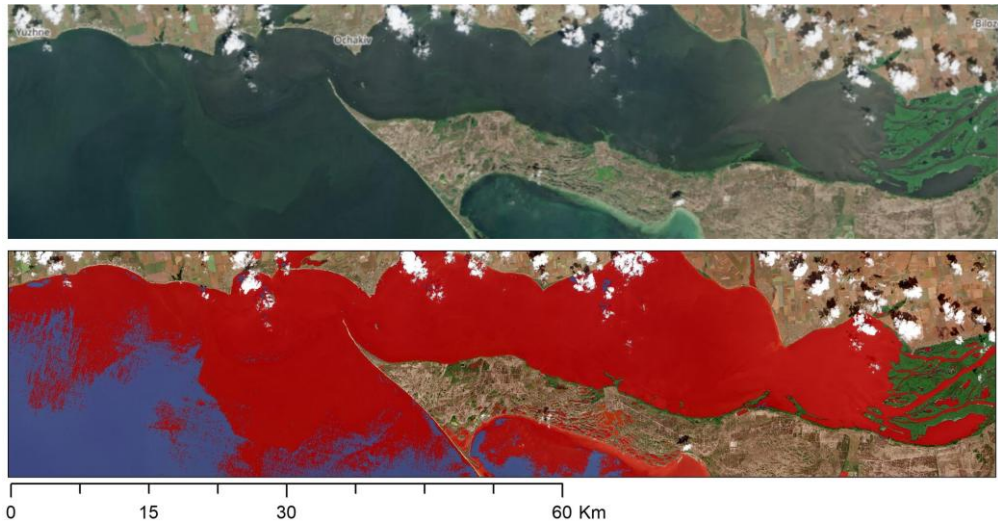
Fig. 15: The area of systematic pollution of the Dnipro-Buh estuary and the Black Sea by high concentrations of pollutants (highlighted in red)

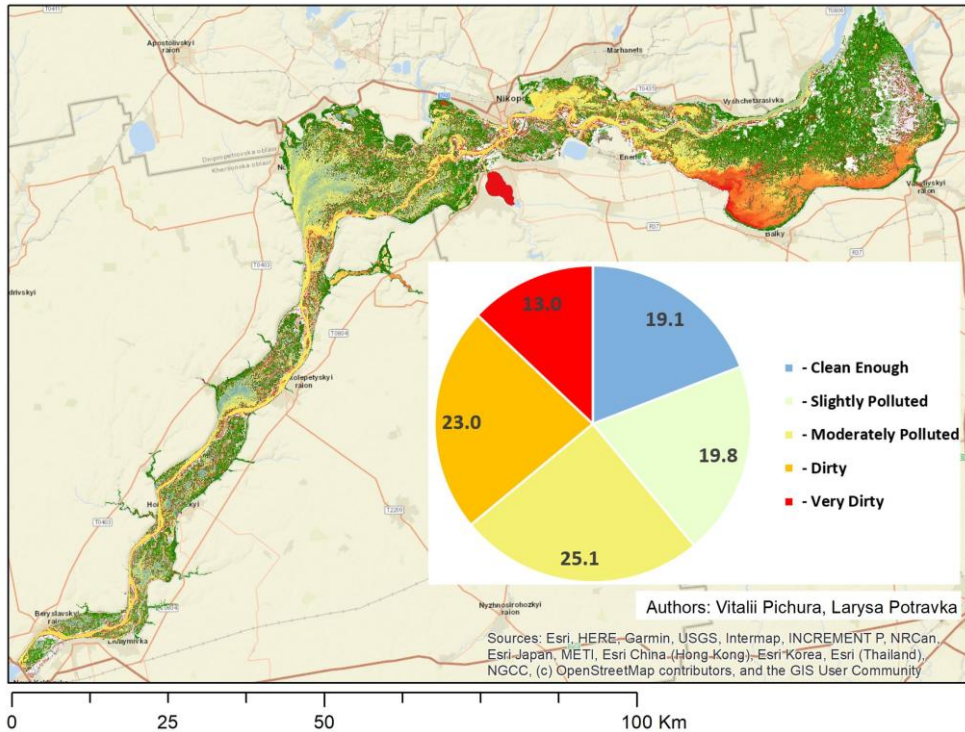
Fig. 16: The Dnipro water quality in the drained Kakhovka Reservoir as of 25/05/2024

Plant residues from the Kakhovka Reservoir are washed away by spring plants and enter surface waters (Fig. 16). In particular, an increase in the number of dead remains and protozoa is caused by washing out by waters from the bottom patches of activated sludge of the drained Reservoir. There was a large number of protozoa, mainly *Oxytricha fallax*, *Vorticella microstoma*, *Uronema nigricans*, *Pseudoglaucoma muscorum*, which are characteristic of a polysaprobic zone (polluted water) with a slow flow and considerable areas of stagnant water masses.

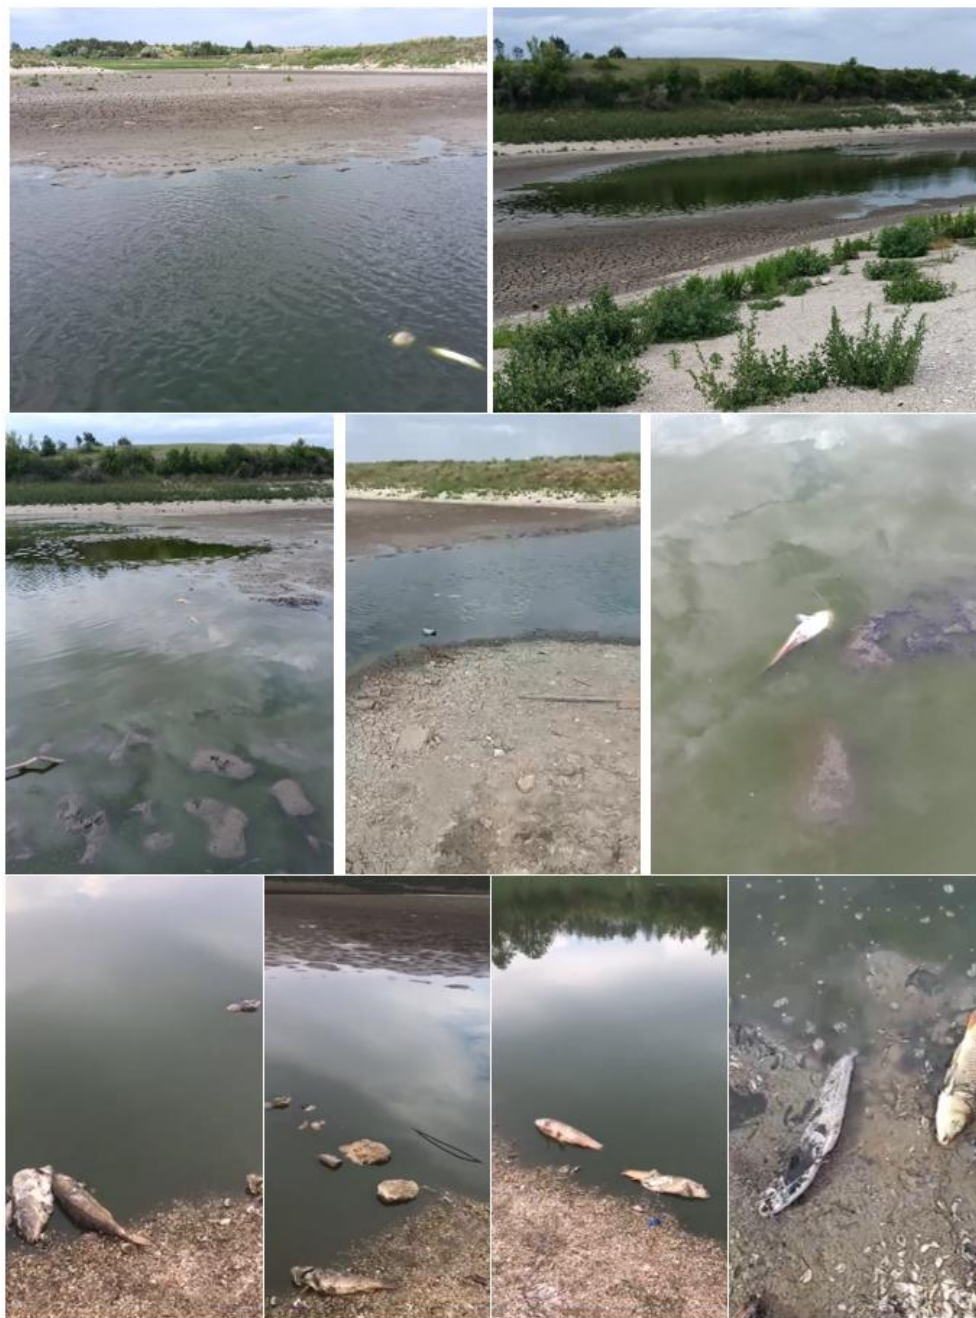
Fig. 17: Isolated shallow water bodies of the drained Kakhovka Reservoir and fish deaths as of 18–24/06/2024

It is noteworthy that significant patches of the aquatic ecosystem destruction within the drained Kakhovka Reservoir are shallow water bodies whose area is unstable and depends on the regimes of the river water withdrawal by the Dnipro HPS and additional water discharge from adjacent territories of the local runoff. In particular, the water withdrawal volumes depend on the seasonal accumulation of rainwater masses in the upper and middle parts of the Dnipro River basin. In this regard, the area of shallow water bodies with a depth of 0.5–2.0 m in the research period varied between 307 and 196 km². These reservoirs are characterized by poor water quality, accumulation of high concentrations of pollutants, a high level of water heating in hot seasons, intensive development of cyanobacteria, active anaerobic processes, an increase in water toxicity, a lack of dissolved oxygen, and death of aquatic organisms. Such negative processes were largely observed at the end of the spring flood, during the water release from the Reservoir, and during an increase in air temperature. Isolated shallow water bodies became a trap for fish during the spawning season causing the deaths of thousands of tons of fish (Fig. 17).

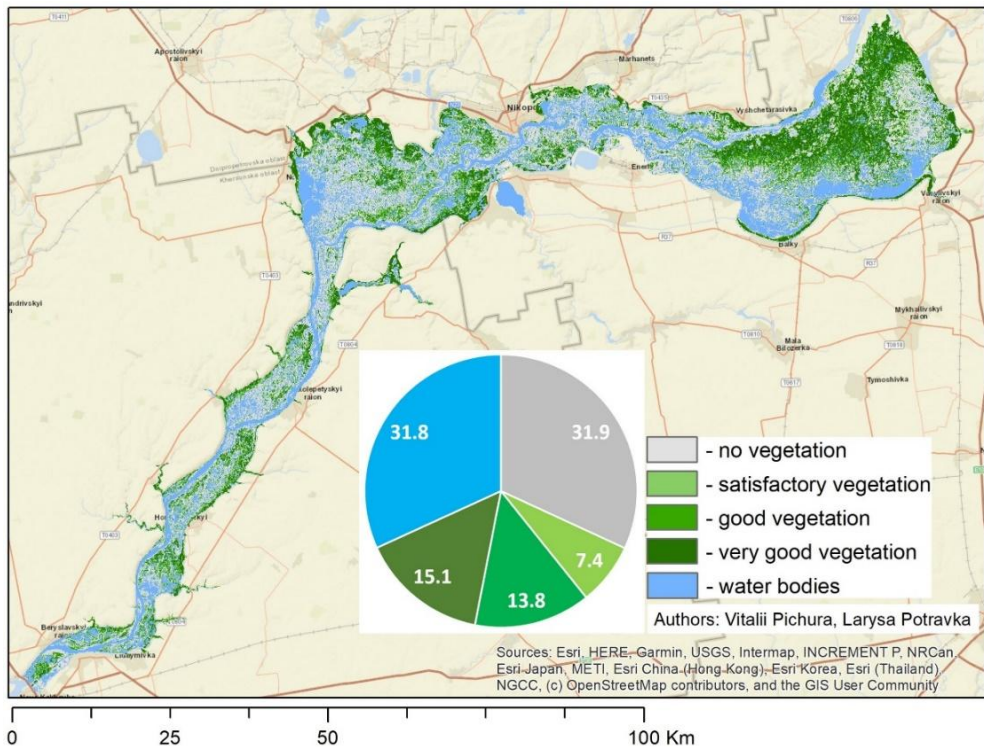
Fig. 18: The distribution of the areas of the drained Kakhovka Reservoir as of 09/06/2024

Formation of plant biomass in the Reservoir and environmental services. In September 2023, in the period of maximum vegetation development, in the territory of the dried Reservoir, according to the indicators of drought intensity and the NDVI value, there was a distribution of the areas (Pichura *et al.*, 2024a): water bodies (16 %); Type I – areas without vegetation (21 %); Type II – open areas with patches of suppressed vegetation and water stress (18 %); Type III – areas with low plant biomass, water scarcity, and considerable temperature pressure (13 %); Type IV – areas with a satisfactory moisture level and plant biomass (20 %); Type V – areas with a good moisture level and healthy vegetation (12 %). At the beginning of June 2024, the area covered by water was 31.8 %, without vegetation – 31.9 %, with satisfactory vegetation – 7.4 %, with good vegetation – 13.6 %, with very good vegetation – 15.3 % (Fig. 18). About 15.3 % (33.0 thousand hectares) of the territory was covered with willows, the remaining 21.0 % (45.3 thousand hectares) is covered by meadow and marsh vegetation (Fig. 19). Most of the territory without vegetation was covered by shells. It was characterized by bare soils, sand, stones, and shallow water.

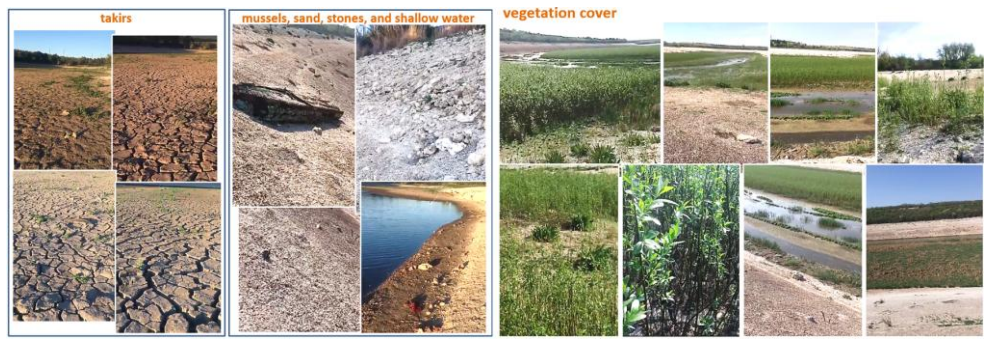
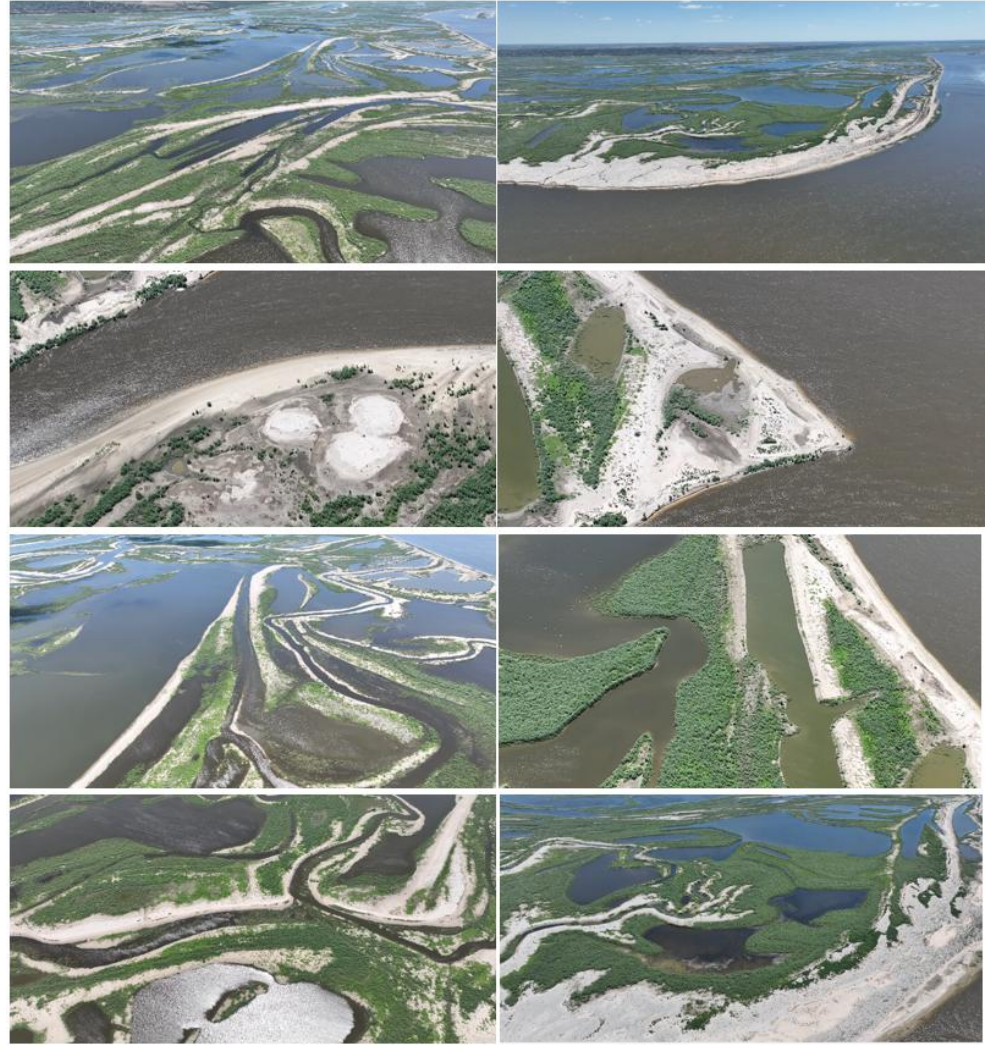
Fig. 19: Mosaic heterogeneity of different areas of the drained Reservoir as of 2024 (the authors' pictures)

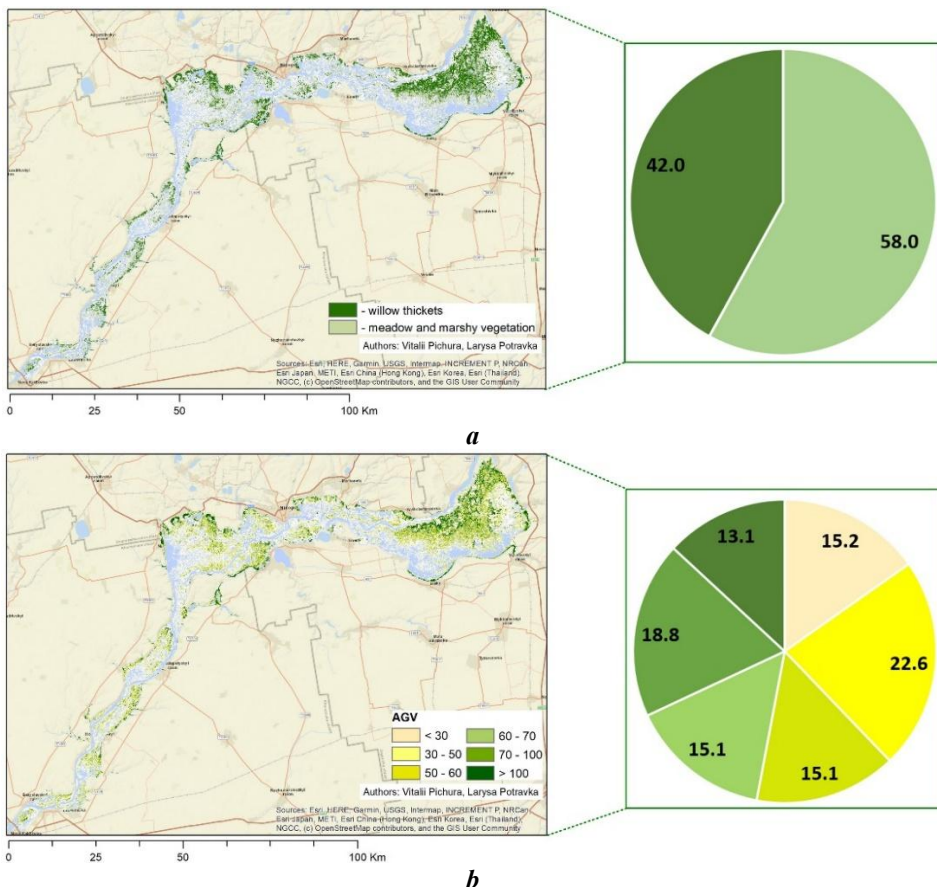
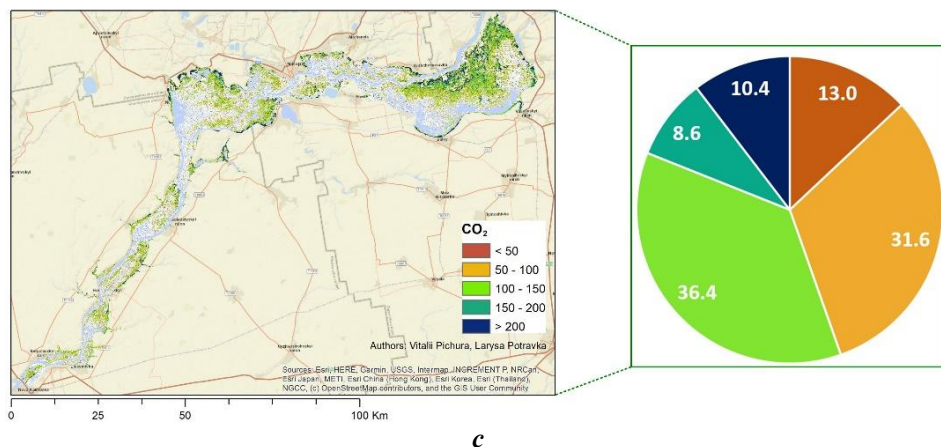
Fig. 20: Environmental atmospheric services of the plant biomass in the territory of the drained Kakhovka Reservoir as of 09/06/2024: a – vegetation structure; b – above-ground biomass, t/ha; c – equivalent of CO₂ reserves, t/ha

The calculation of the Above Ground Biomass (AGB) of plants allowed for establishing that the biomass formed in the area of 78.3 thousand hectares within the territory of the drained Kakhovka Reservoir as of 09/06/2024 (Fig. 20a) had the following structure: woody plants mainly represented by willows – 42 %, meadow and marsh plants – 58 % of the territory. About 4.7 million tons of above-ground biomass was formed over the year (Fig. 20b). The vegetation patches were uneven, with sparse (0.1 t/ha) and dense (287 t/ha) growth. The average biomass value was 61.3 t/ha. The patches of well-developed woody plants formed more than 40 t/ha of biomass. The biomass of meadow and marsh vegetation ranged from 5 to 75 t/ha. The formation of natural biomass in terms of environmental-atmospheric services is estimated at 8.5 million tons in the total equivalent of sequestration and carbon dioxide reserves (CO₂) (Fig. 20c). However, it does not compensate for the volumes of carbon sequestration provided in the past by agroecosystems in an area of 2.5 million hectares of irrigated and adjacent lands. According to our calculations, the equivalent of the total carbon dioxide sequestration provided by agroecosystems amounted to more than 230 million tons.

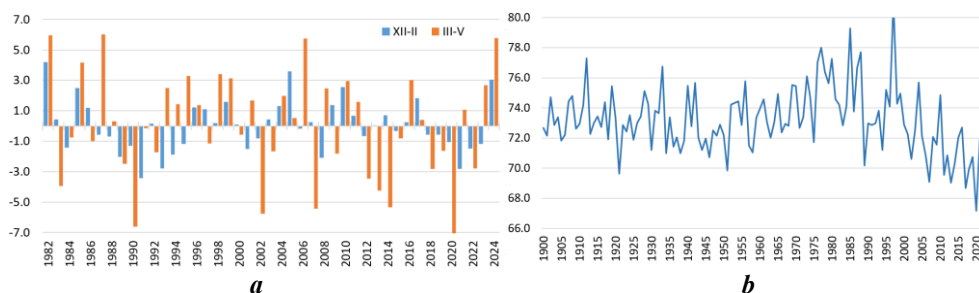
Fig. 21: Dynamics of relative air humidity (%) within the Kakhovka Reservoir in 1982–2024: a – deviation from the statistical norm in winter (79.8 %) and spring (68.6 %) periods; b – the average annual value

A combination of moisture and the availability of nutrients of bottom sediments can explain the rapid growth of plant biomass. Notably, the winter-spring period of 2024 was characterized by favorable climatic conditions, which could be regarded as abnormally favorable in terms of available moisture. In particular, similar conditions were observed in 1982 (Fig. 21a). The total value of relative air humidity in the winter-spring period of 2024 exceeded the statistical norm for 1982–2024 by 8.8 %, whereas the excess was 10.1 % in 1982. Abnormally high moisture content was observed in the entire catchment area of the Dnipro River that led to the accumulation of large water volumes in the main river course, good hydrological conditions, and an increase in the frequency of surface water discharges from the Dnipro HPS to the territory of the Kakhovka Reservoir. Therefore, these conditions can be referred to as untypical conditions of Ukraine’s Steppe zone, which contributed to plant survival and substantial growth. In particular, over the past 40 years (Fig. 21b), there has been a steady decline in relative air humidity by 10–12 %, causing the worsening of water shortages and an increase in temperature pressure on the territorial ecosystems.

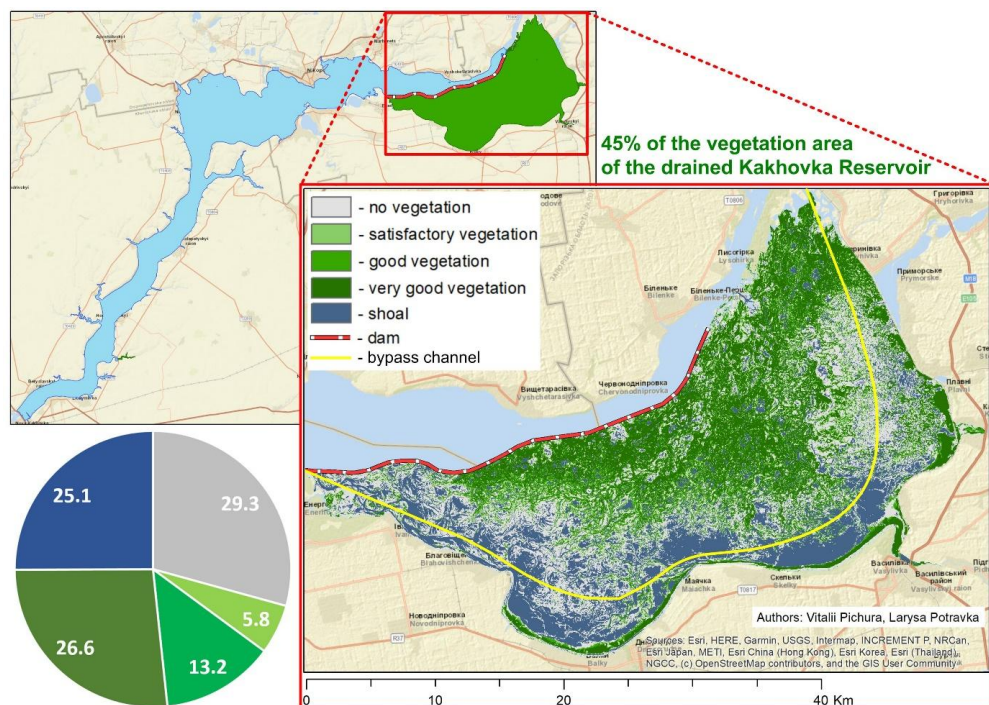
Fig. 22: The natural-artificial system of the Kakhovka Reservoir

It is noteworthy that the separation of the shallow water area of the Reservoir by the dam may cause water shortages and the destruction of the quasi-natural environment. Therefore, it is essential to create a bypass channel (Fig. 22 – highlighted in yellow) in this territory to maintain the necessary moisture level in hot seasons to preserve and develop plant biomass. The bypass channel will become an important additional source of water supply to satisfy the population's sanitation needs.

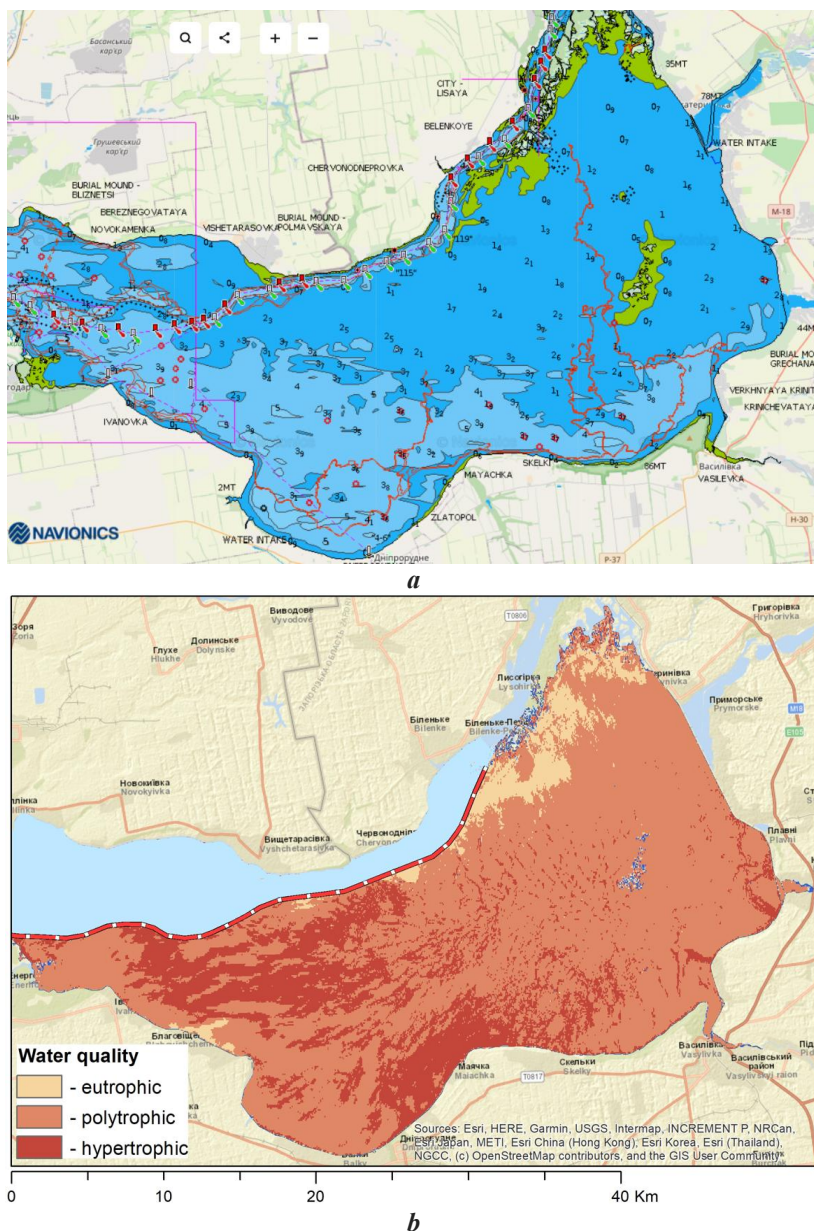
Fig. 23: Bathymetric characteristics and water quality in the territory separated by the Kakhovka Reservoir Dam as of 2022: *a* – depth marks, m (the data source, <https://ua.fishermat.org/depth-map/kahovskoe-vodohranilische/#map>), *b* – the formation of water quality by hydro-biological characteristics

The quasi-natural environment is a “second nature environment” that includes all the elements of the natural environment artificially transformed and modified by people. Unlike the natural environment, the quasi-natural environment is not capable of sustaining itself and requires periodical investments of resources. Therefore, an artificial water supply for this territory is necessary for preserving and maintaining the quasi-natural meadow-marsh and forest environment. To create the quasi-natural environment, scientists have proposed the separation of the upper shallow water area occupying 725 km² (34 % of the Reservoir’s territory) with a dam. Before the Kakhovka dam destruction, this area was mainly characterized by a depth of 0.7–2.5 m (Fig. 23a) and contained about 18 % of the Reservoir water volume. 11 % of the water reserves did not participate in flow regulation causing water stagnation and the formation of patches of polytrophic-hypertrophic water masses (Fig. 23b), part of which moved downstream.
