SCENARIOS FOR THE FUNCTIONING OF THE KAKHOVKA RESERVOIR TERRITORY

VITALII PICHURA^{1*}, LARYSA POTRAVKA¹, NATALIYA STOIKO²
AND HALYNA DUDYCH²

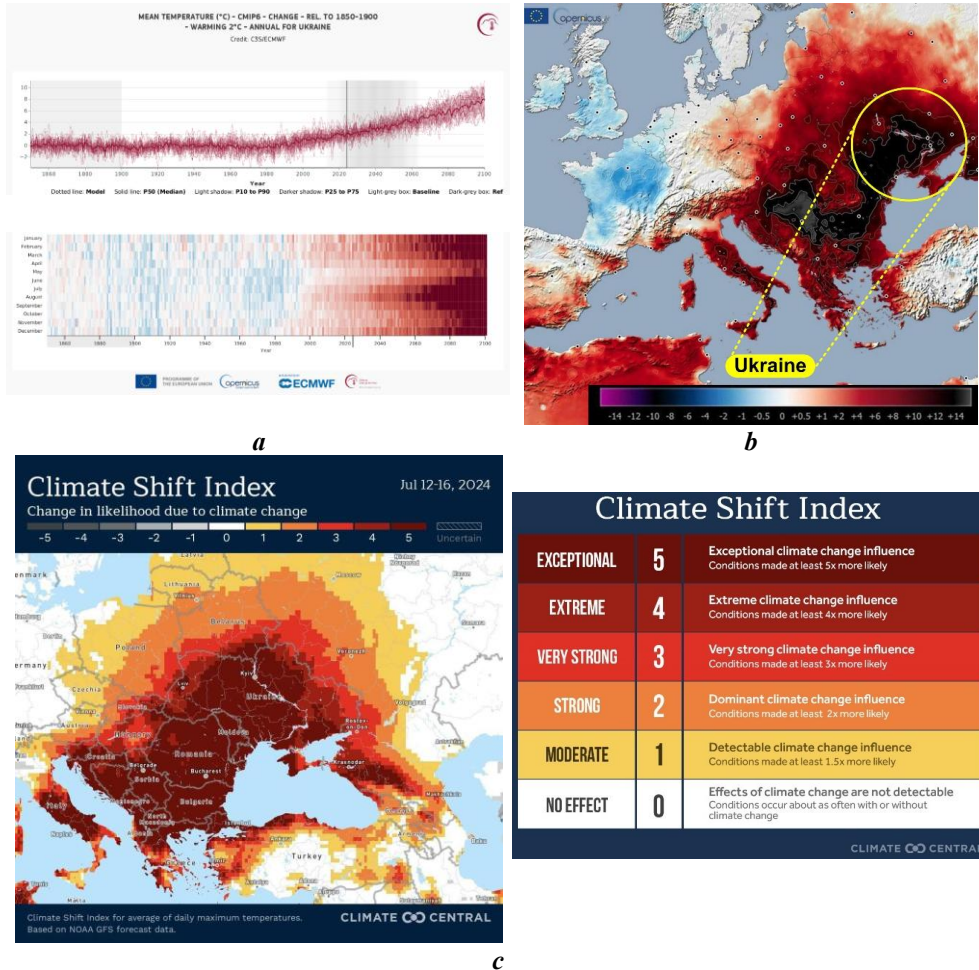
Fig. 24: Changes in the air temperature in Ukraine: *a* – average annual and seasonal changes in the temperature in relation to the statistical norm of 1850–1900; *b* – the air temperature as of June 12–19, 2024, in relation to the statistical norm of 1991–2010; *c* – Climate Shift Index as of July 12–18, 2024

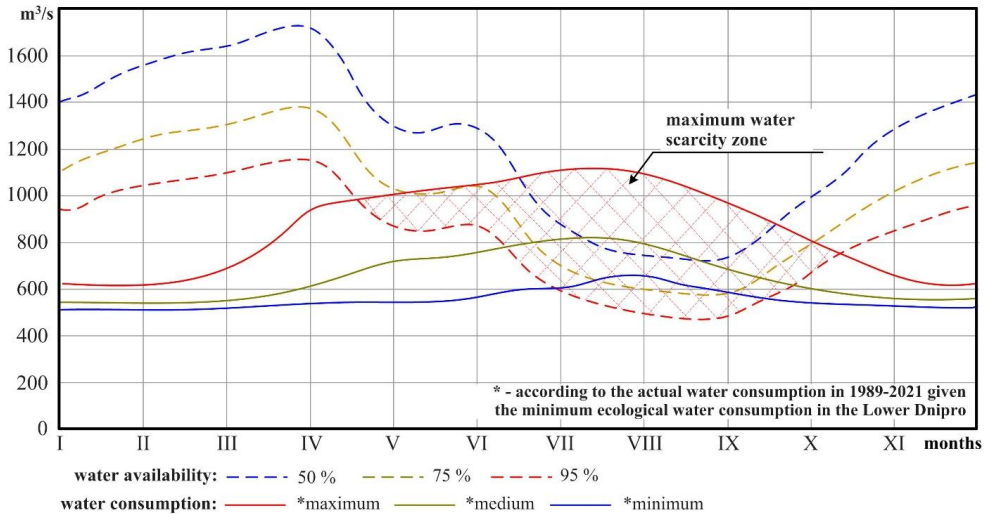
Fig. 25: The model of water supply in the southern regions of Ukraine (m^3/s) depending on the actual water availability in the Dnipro riverbed in 1981–2021

It should be highlighted that the direct water withdrawal from the Dnipro riverbed will cause a sharp reduction in its water content, deterioration of the hydrological regime and river regulation, an increase in the concentration of pollutants, significant water pollution, and the death of aquatic bio-resources.
